ANPP CORROSION PROGRAM

Final Summary Report

MND-E-2727

February 1962

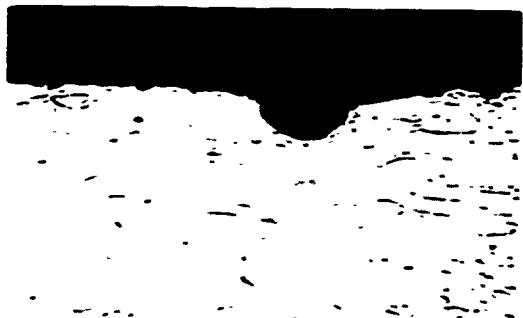
Fig. 12. Photomicrograph of Nickel Specimen Showing 0.90035-Inch Deep Pit (750x Mag)

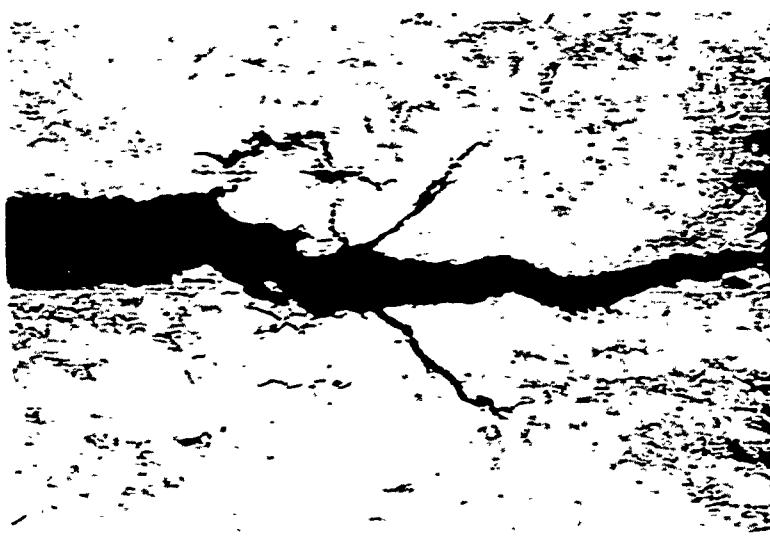
Fig. 19. Photomicrograph of MIN 1, Area "F" of Fig. 16. The Full Tube Thickness Was Penetrated. The Narrow End of the Crack Is at the ID
Magn 100x

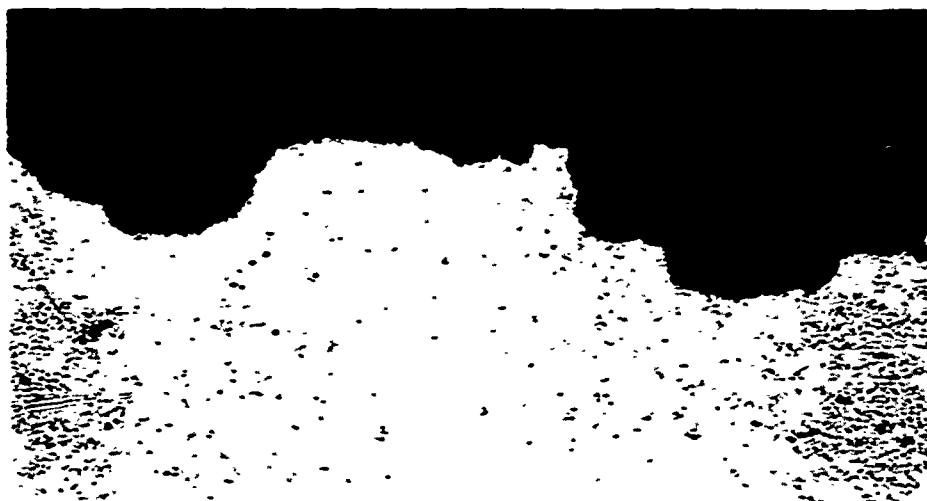
Fig. 24. Section Taken from Secondary Side Tube Exposed to Steam Phase--Worst Case of Pitting Seen in MIN 4 or MIN 5

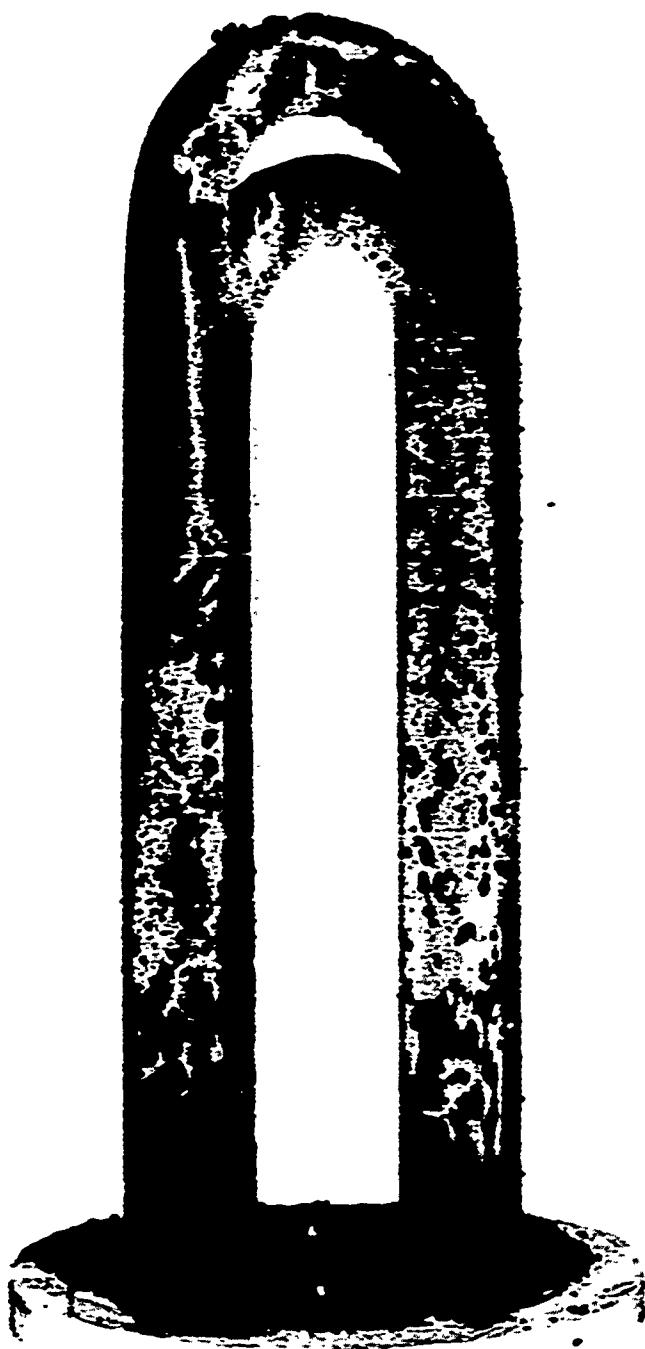
Figure 25 shows the tubes with the corrosion products as removed from the shell. Examination of the secondary tube and tube sheet surfaces revealed no evidence of cracks, as expected.

Fig. 25. MIN 7 with Secondary Shell Removed

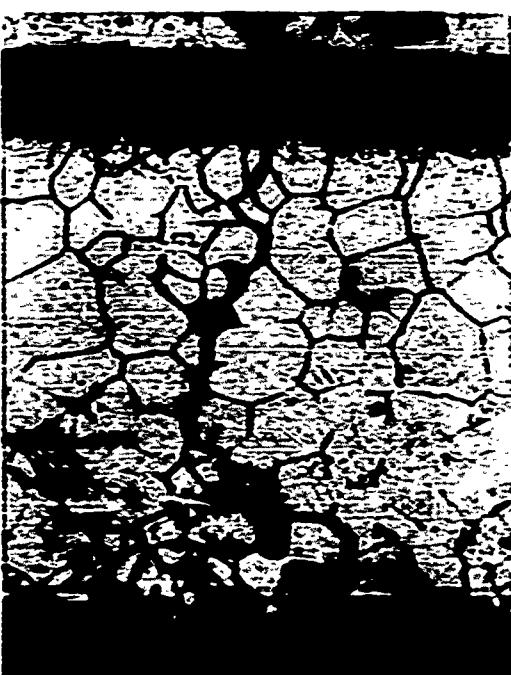
Fig. 20. Intergranular Cracking in Type 304 SS
Clad of Bimetal Tube Containing Numerous
Irregularities (MIN 7) Magn 250x
